Broadway and Cruse Parking Garage

Preliminary Engineering Report

Prepared For:
Dept of Administration
1310 East Lockey
Helena MT 59620

Prepared By:
Stahly Engineering & Associates, Inc.
3530 Centennial Drive
Helena, MT 59601
(406) 442-8594

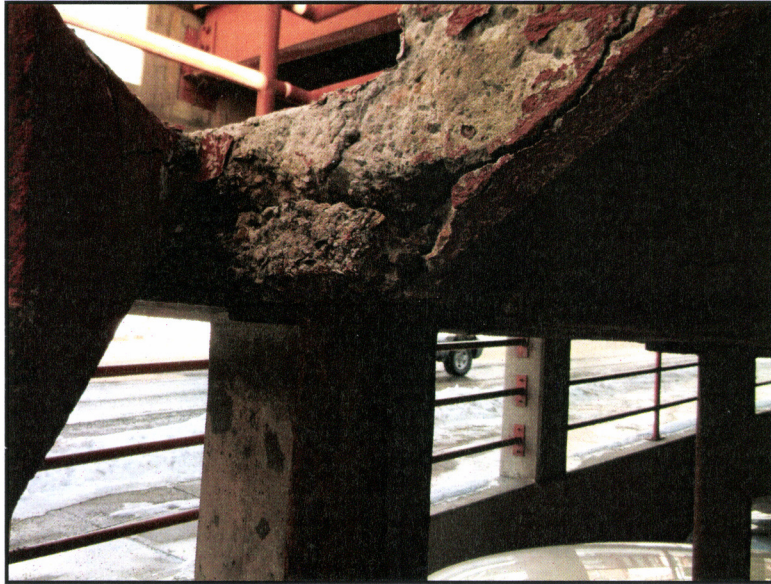
The condition of the concrete deck could not be observed due to the asphalt mat. It can be assumed due to the condition of the composite deck underneath that there is considerable deterioration of the concrete in areas, which is continually worsened by the freeze/thaw conditions. The concrete walls were observed to be in good condition, with the exception of concrete in several areas at the beam to concrete connections. The most notable area of concern with the concrete is located at the stairs. This concrete has excessive deterioration and poses a serious safety hazard.

Figure 2 - Concrete Deterioration at Stairs

For this structure to be partially rehabilitated, portions of the concrete deck would need to be removed and replaced. This would require saw cutting through the deck to remove specific portions. Any area of the steel deck pans (composite decking) that have visible corrosion would be identified. This method of replacement would require the removal and replacement of the entire section of concrete deck in between the adjacent steel beams even if only a small section of the deck between the beams was corroded. Overall, this option could require the replacement of a larger area of the deck than is visibly corroded due to the manner in which sections would need to be replaced. Additionally, the stairs for the garage are an obvious concern, and removal and reconstruction would be necessary.

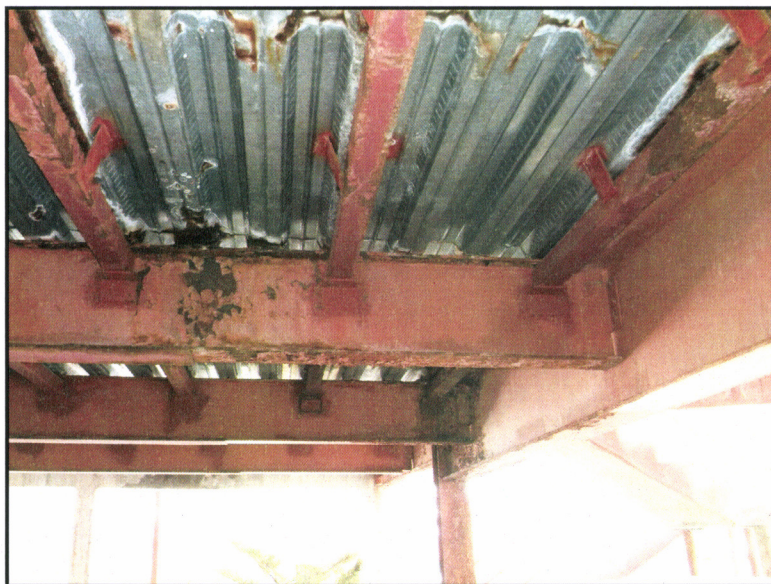
The deck of this structure is comprised of composite decking. This composite decking acts both as forms during construction, and is also a structural component. Typically, composite decking contains no reinforcing steel. It is important to the structural integrity of the deck for the composite decking to remain in good condition. Due to the water that has infiltrated through the upper deck, the composite decking has experienced considerable corrosion in certain areas.

Figure 3 - Composite Decking

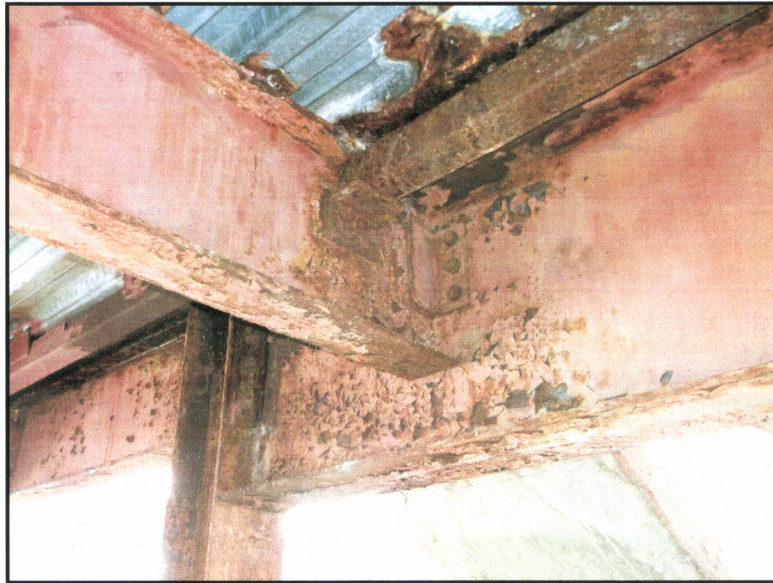
The steel members supporting the concrete deck have experienced significant corrosion. The most corroded area is located near the stairs, although there are other areas throughout the structure that show signs of deterioration. One location in particular is at the light post connections that are on the W36x194 beam along the center of the structure. These connections have allowed moisture through the deck and have deteriorated the beams.

Figure 4 - Steel Beam Corrosion

Select steel beams in this alternative would require sandblasting and painting in order to prevent further corrosion. Since this alternative has the lowest life span, only heavily corroded steel beams in the areas of most concern would be selected to be sandblasted. Out of the roughly 8000 square ft surface area of the steel beams, we are assuming 1000 square ft would require sandblasting.

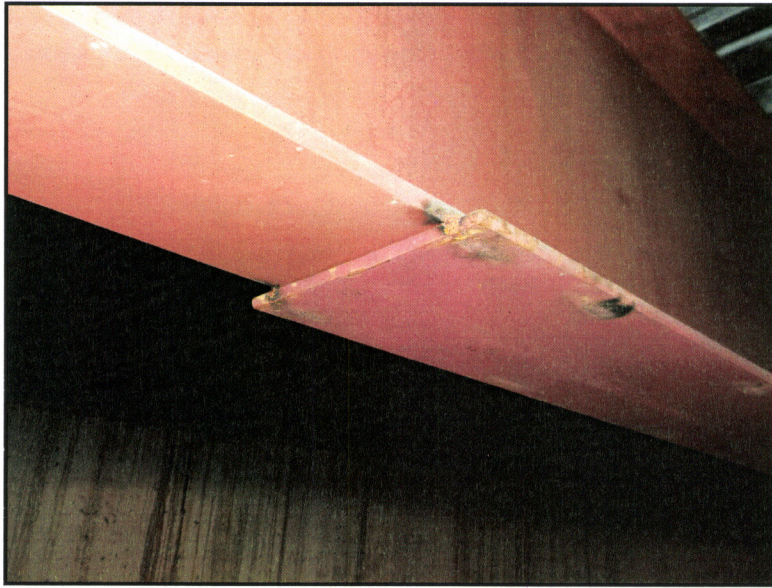
We assume the asphalt mat was added to the upper deck to prolong the life of the parking structure. It is also our assumption that the addition of the asphalt, which weighs approximately 40 psf, likely resulted in the addition of steel plates ($\frac{3}{8}$ " thick, 8" wide) to reinforce the W18x40 steel beams that run in a north - south direction.

Figure 5 - Steel Plate Welded to W18x40 Beam

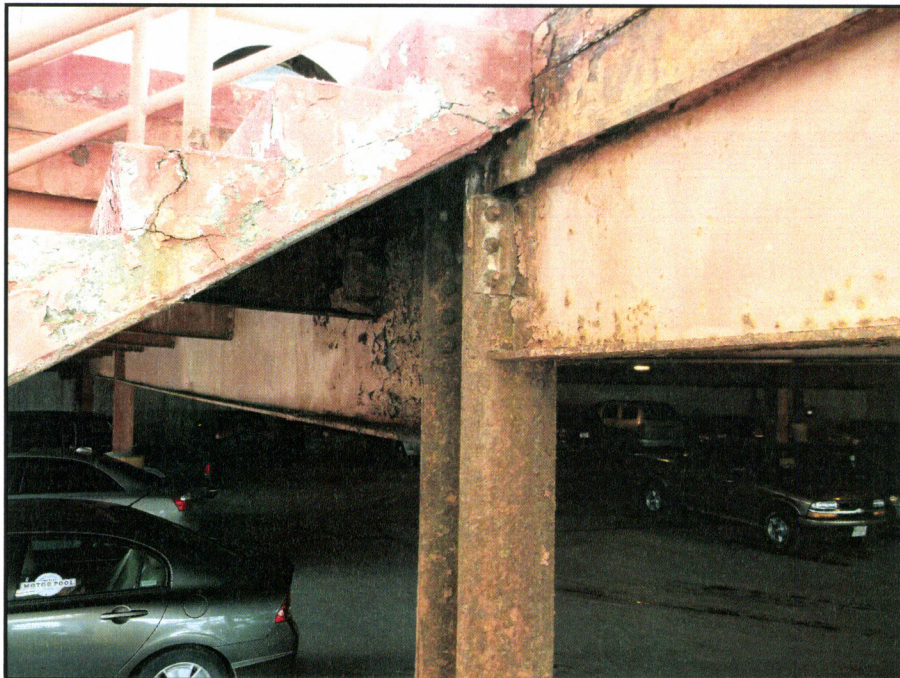
It was observed that the steel to steel connections lack the ability to allow for thermal movement of the structure. Changes in temperature cause the steel to expand and contract, and lack of flexibility can lead to problems within the steel connections. Gaps could be observed in some of the connections due to this inability for the structure to flex.

Figure 6 – Steel Connections

Following deck removal, certain steel to steel connections could be altered in order to allow for thermal movement. This would entail shoring up the steel beams and switching the connections out with slotted connection pieces that give the structure the capability to move with thermal expansion and contraction.

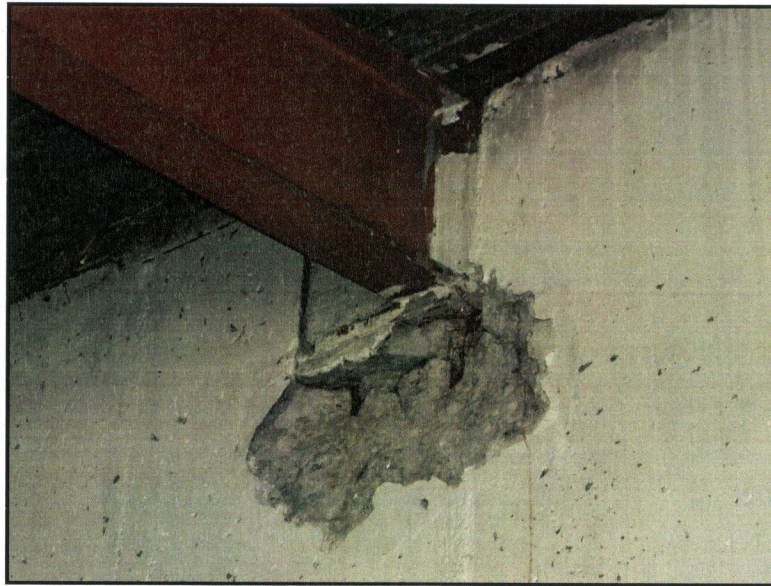
Some of the steel to concrete connections in the structure have also experienced deterioration. This could be caused by water leaking through the deck and causing damage by freeze/thaw conditions. There were also areas that appear to have undergone repair. One connection that had been damaged by spalling was unsuccessfully saw cut in a repair attempt. It appears that this effort was abandoned, and the beam was supported with tube steel that was bolted to the concrete wall (Figure 8).

Figure 7 - Deterioration of Steel to Concrete Connection

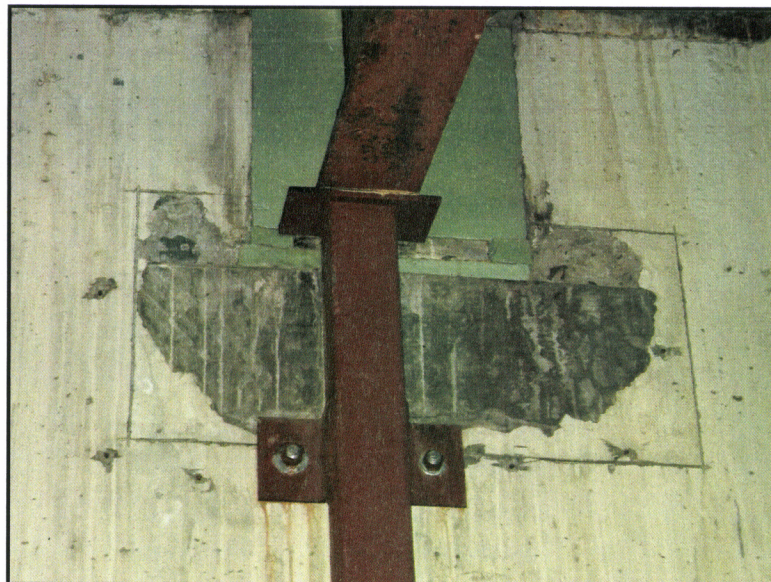
Figure 8 - Previous Repair Work at Steel to Concrete Connection

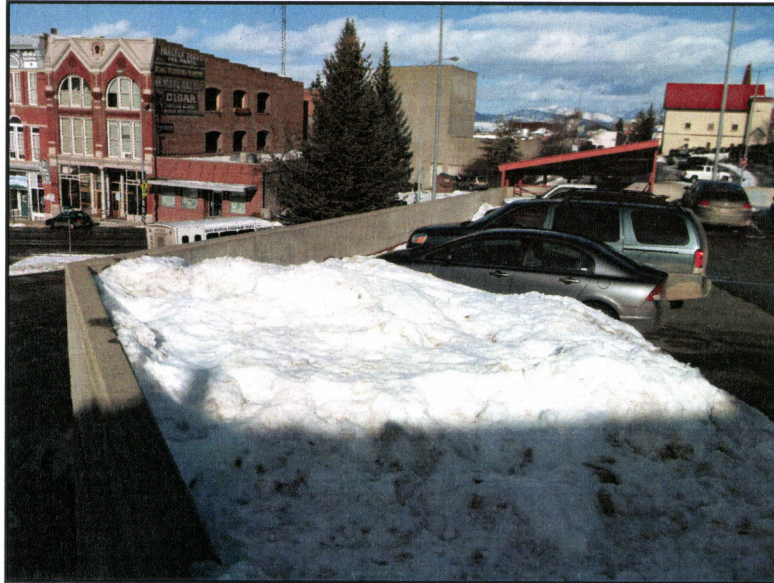
Part of the drainage issue on the deck is the inability for snow to be stored outside of the parking lot footprint. The result is a large amount of snow that is stored on the South West corner of the lot. This pile of snow melts and drains towards the North West corner, contributing to further water damage.

Figure 9 - Snow Storage Area

This alternative would include design and construction of a snow storage area. This would likely consist of a new location for a retaining wall and level pad for snow storage on the SW corner.

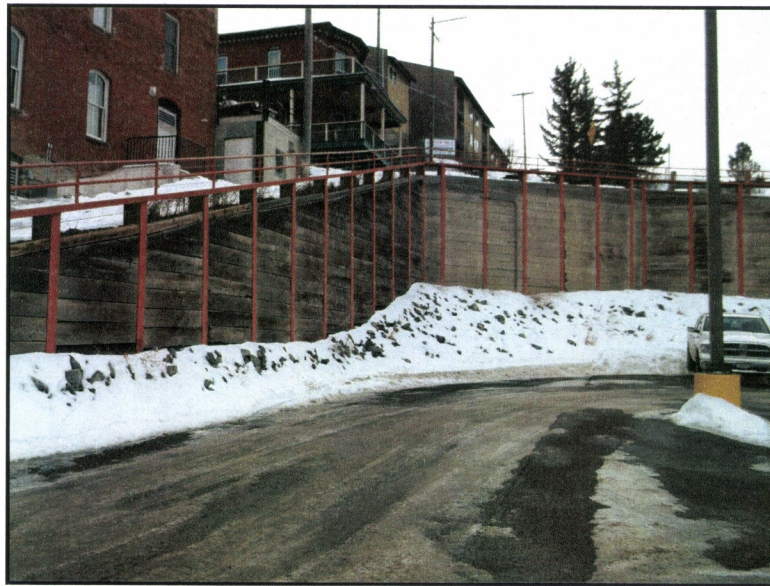
Due to the topography of the site, the excavation required to build a new structure could require soil shoring (possibly shotcrete). The purpose of the shoring would be to prevent the existing steel and timber retaining wall that wraps around the South and East sides of the upper parking level from being destabilized as the adjacent areas are excavated.

Figure 10 – Steel and Timber Retaining Wall
